EXPERIMENTAL SAND DRAIN FILL AT NAPA RIVER

By
William G. Weber Jr.
Senior Materials & Research Engineer

Presented at
45 th Annual Highway Research Board Meeting
Washington D.C.
January 17 to 21, 1966

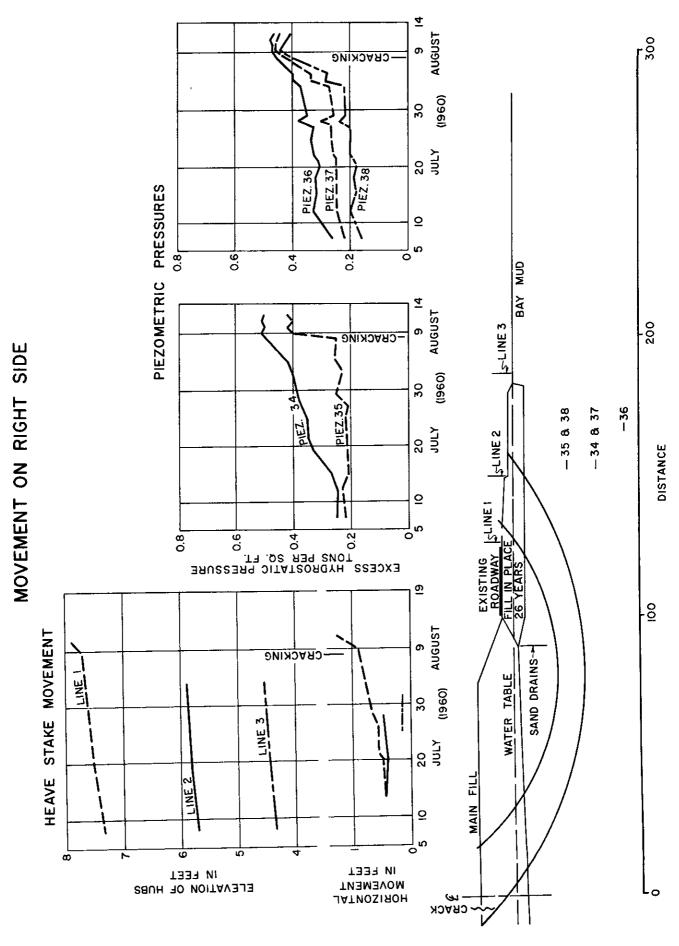
A cross-section of the fill is shown in Figure No. 3 along with the minimum failure arc. Stability analysis indicated that no significant increase in strength of the underlying foundation soil had occurred. Two minimum failure arcs with factors of safety just below unity were located and indicated that heave of the roadway or existing fill was occurring. This was in agreement with the observations that no visible movement of the mud surface to the right of the existing fill occurred, and that the roadway fill was rising.

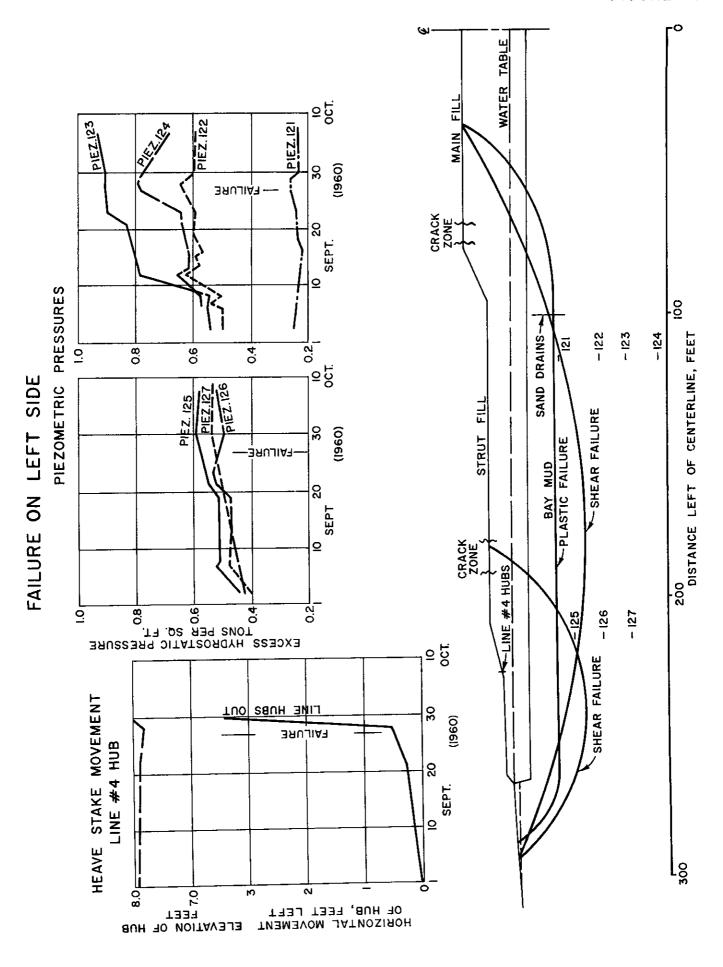
On September 27, 1960, a major movement occurred on the left side as shown in Figure Nos. 1 and 4. The piezometers at the toe of the main fill had been indicating a slow steady rise in excess hydrostatic pressure prior to the failure. The heave stakes had indicated a small steady outward movement, and the slope indicators showed that a minor flow of the soft bay mud was occurring at about elevation -10 feet. This movement occurred very rapidly with about a 4-foot drop in the left side of the fill.

The stability analysis of this movement are shown in Figure No. 4. The shear circle analysis indicated a factor of safety of unity existed. Using the stability analysis for plastic type movements developed from analysis of the failures at Candlestick Cove(3), the results indicated a factor of safety of 0.7. The rapid development of a large mud wave and the general appearance of the area indicated that this plastic type of failure had occurred. There was no indication that a significant increase in strength of the soft foundation soil had occurred.

This shallow shear failure through the upper portions of the soft foundation soil was not expected. It had been expected that the upper portions of the soft foundation soil would consolidate rapidly, increasing the shearing strength of the soil immediately

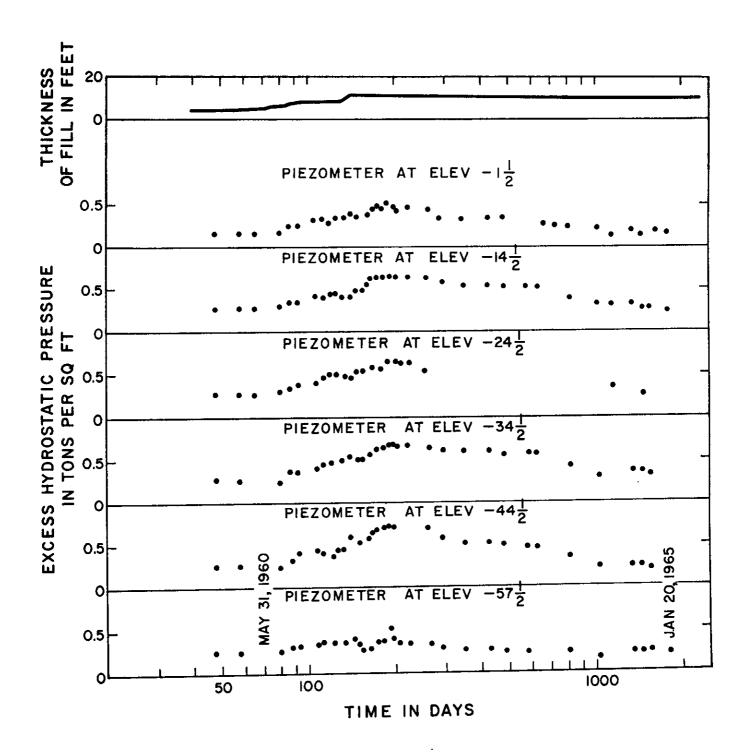
VARIATION OF EXCESS HYDROSTATIC PRESSURE WITH DEPTH NON SAND DRAIN AREA

Piezometers were placed at various depths in the foundation soil in the nonsand drain areas below the main fill and the berm, to measure the rate of consolidation of the foundation soil without sand drains. A typical set of data is shown in Figure No. 10, which is in the berm area to the left of the main fill. As the piezometers were read every other day during construction

only representative data is shown during this period. The excess hydrostatic pressures rose during the loading of the foundation soil and decreased when the load remained constant. The excess hydrostatic pressure reached a maximum of 0.65 tons per square foot under a fill loading of 0.70 tons per square foot. After completion of the fill the pressure has slowly dissipated until in 1965 about 60 percent consolidation has occurred. This is in agreement with the settlement data.

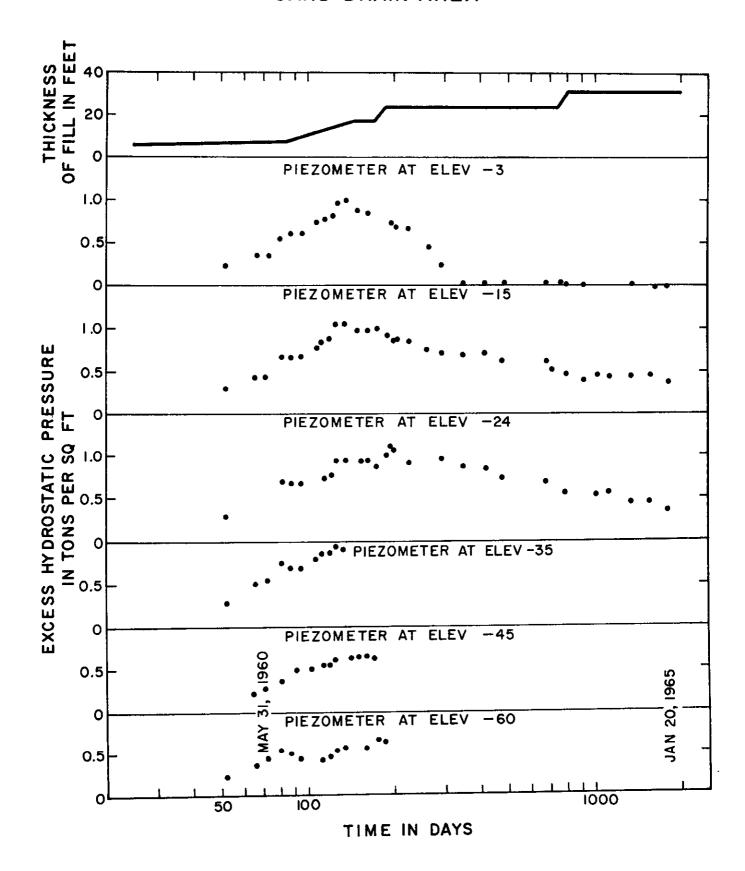
VARIATION OF EXCESS HYDROSTATIC PRESSURE WITH DEPTH SAND DRAIN AREA

The excess hydrostatic pressure increased as loading occurred and then decreased as the load was maintained constant. The maximum excess hydrostatic pressure was 1.0 ton per square foot at the end of loading under a load of about 1.4 ton per square foot. In Figure No. 13 this same data has been plotted with excess hydrostatic pressure as a function of depth at given The data indicates that at the time of the failure on the left side about 40 percent consolidation had occurred. settlement curves at the location of these piezometers are shown in Figure No. 8, and the settlement data is in reasonable agreement with the excess hydrostatic data. The piezometers below elevation -35 failed to function properly after loading was completed so that the data is incomplete for this period. these malfunctions occurred for most plezometers at greater depth after loading was completed and the lines appeared to be pinched. That is a wire would not go through the plastic tubing to the porous stone, but would be stopped above the porous stone (5). Prior to placing the additional load in 1962 the piezometers indicated about 70 percent consolidation had occurred which is in agreement with the settlement data. At the present time the piezometer data indicates that about 90 percent consolidation has occurred whereas the settlement data indicates that the settlement is completed. This minor discrepancy is not considered serious. This data is typical of the data obtained at five other locations in various sand drain areas.

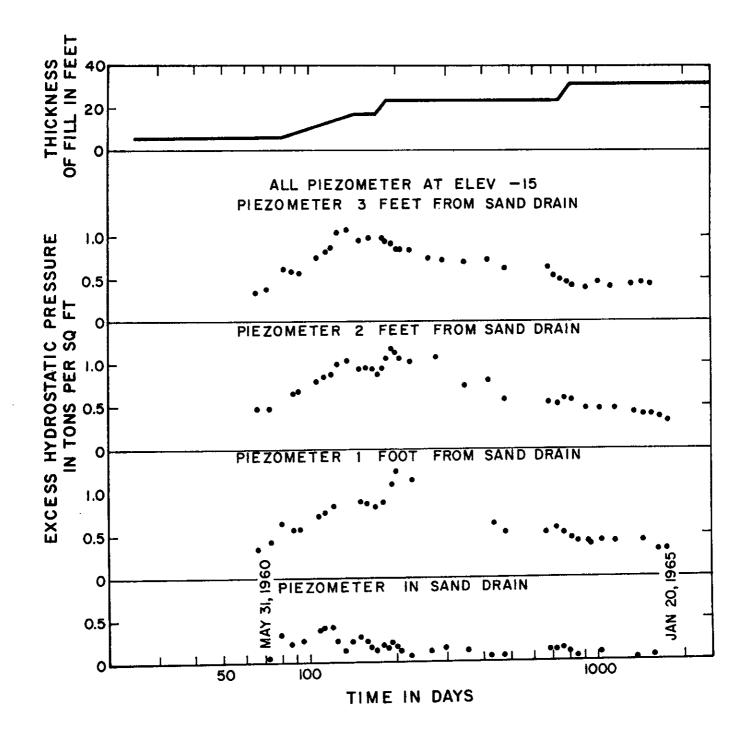
VARIATION OF EXCESS HYDROSTATIC PRESSURE WITH DISTANCE FROM SAND DRAIN

excess hydrostatic pressure variation with time. The pressures in the native soil were constant with distance from the sand The excess hydrostatic pressures as a function of the distance from the sand drain at any given time are shown in Figure No. 15. The data indicate that the expected hyperbolic pressure distribution did not develop, even after a period of several years. This condition existed at all three test loca-The blockage of drainage at the peripheral smear zone appears to be the reason for this condition. As a routine operation, the permeability test was performed on each piezometer after it was installed (9). A review of these data indicated that the permeability indicated by the piezometers one foot from the sand drain was 1/5 to 1/10 the permeability two to three feet from the sand drain. It would thus appear that the smear zone extends outward from the sand drain one to two feet. The permeability two to three feet from the sand drain was slightly lower than the permeabilities indicated by other piezometers prior to the driving of the sand drains. No data was obtained at the same piezometer location before and after driving sand drains. However, the data is fairly consistent at the three test locations.

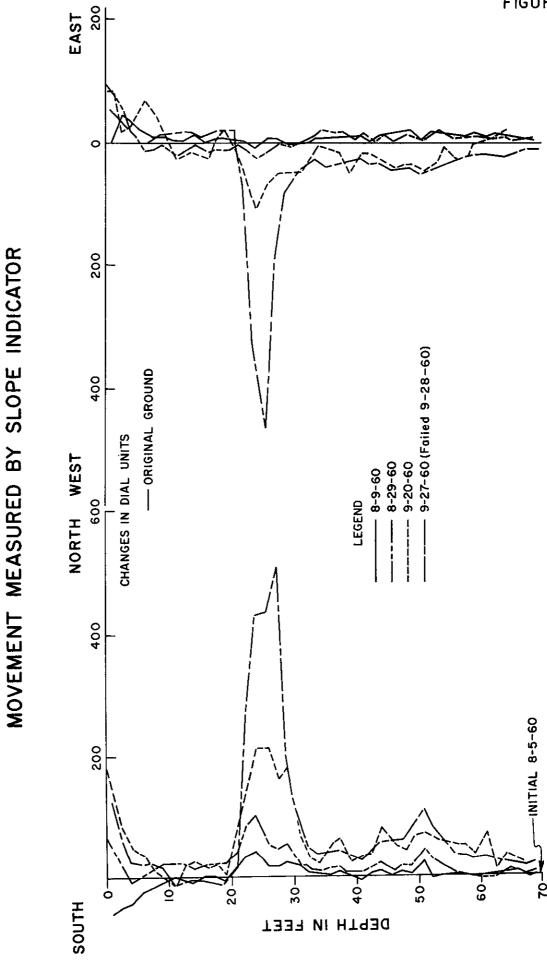
MOVEMENT MEASURED BY SLOPE INDICATOR

The data obtained from a slope indicator to the left of the fill in the area that failed is shown in Figure No. 21. This installation was destroyed during construction and reinstalled after the berms were widened on the left. As loading of the main fill was resumed, after the failure on the right, a minor movement was noted at a depth of 25 feet below the top of the tubing. On the morning of September 27th this installation was read. When the data was reduced and plotted on the norming of the 28th, after the failure, it was found that the slope indicator had indicated a major movement occurred at a depth of 25 feet. This indicates how the time delay is critical in stability problems. On September 28, 1960, it was found that the tubing had failed at a depth of about 20 feet.
